# Inspection Report

**Property Address:**  
355 Lime Rd. N.W.  
Lake Placid FL 33852

**Advanced Home & Insurance Inspections LLC.**

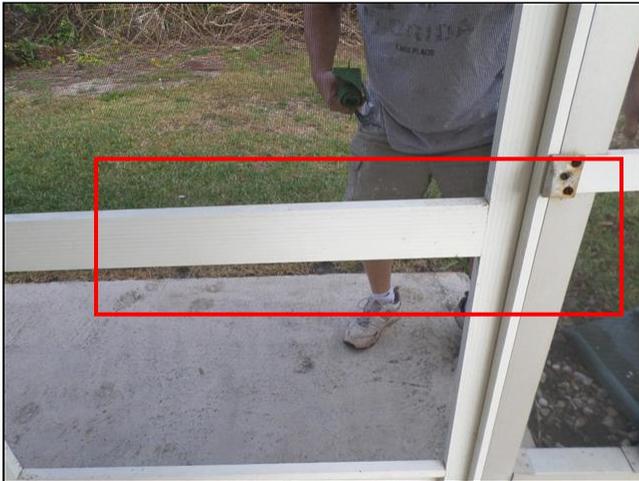
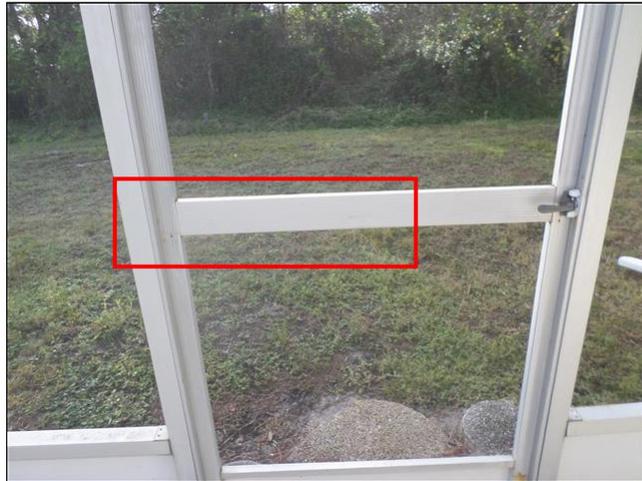
2.1 Item 1(Picture)

**2.1** The screen doors for the pool cage at the rear of home are missing a closures. This is a small repair. I recommend repair as desired.

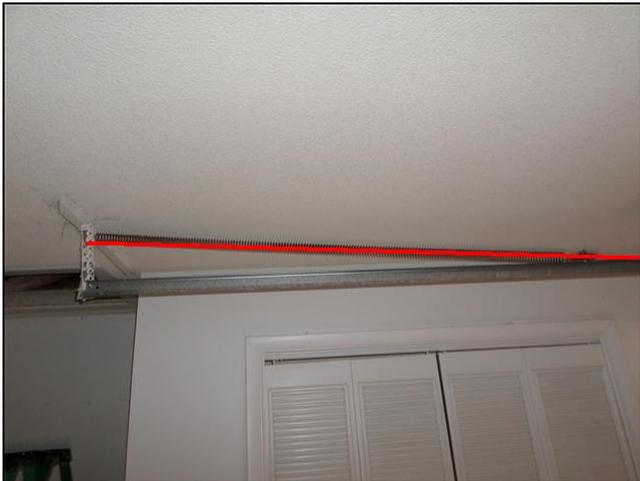
3.3 Item 1(Picture)

**3.3** The springs for garage door (s) at the front of home missing retention cables (in case springs break to prevent injury). This is considered unsafe and needs correcting. A qualified person should repair or replace as needed.

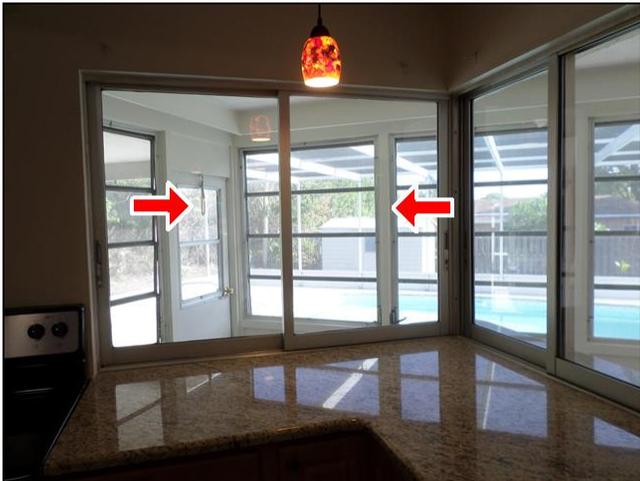
4.5 Item 1(Picture)

4.5 (1) The pass through window stuck (I could not open) at the Kitchen. A repair may be needed. A qualified person should repair or replace as needed.

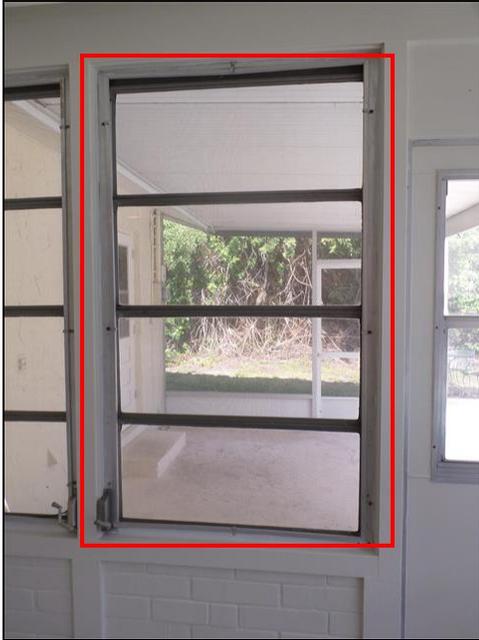
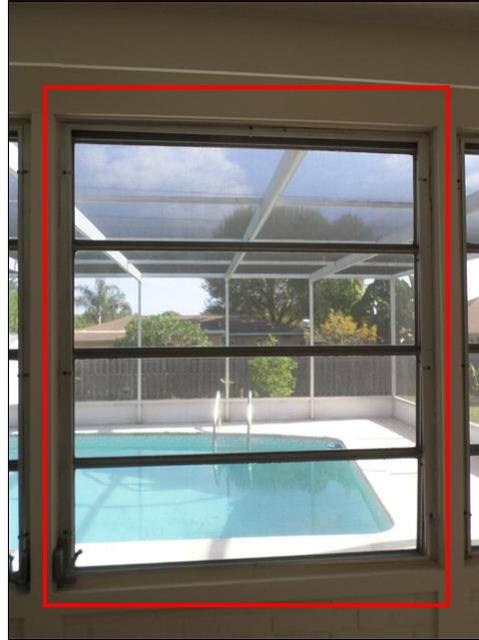
4.5 Item 2(Picture)

(2) Two windows does not shut properly at the Lanai. A repair may be needed. A qualified person should repair or replace as needed.

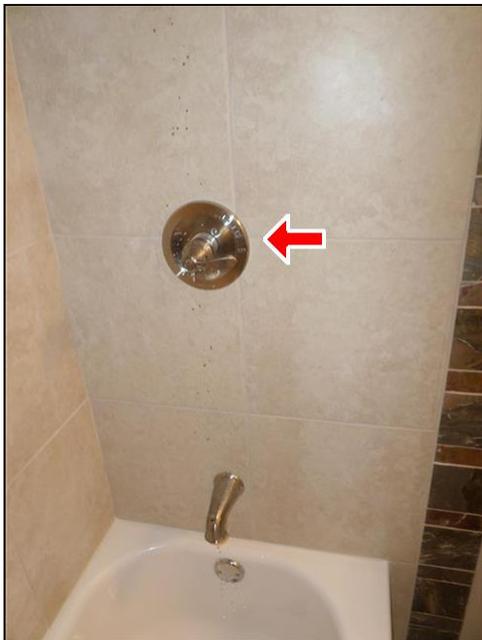
6.1 Item 1(Picture)

**6.1** The tub faucets is reversed (hot is cold, cold is hot) at the hall bath. This is for your information. I recommend repair as desired.

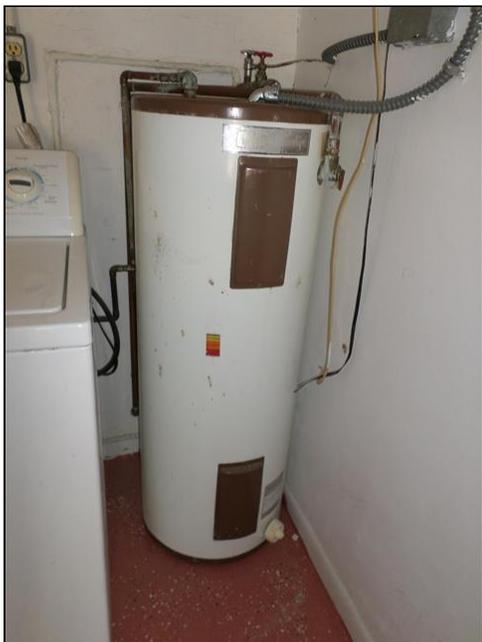
6.2 Item 1(Picture)

**6.2** The water heater does work and no apparent problems were found but the water heater is old. The average life expectancy of a water heater is 10 to 15 years. I am unable to determine how much longer the water heater will last. This is for your information.

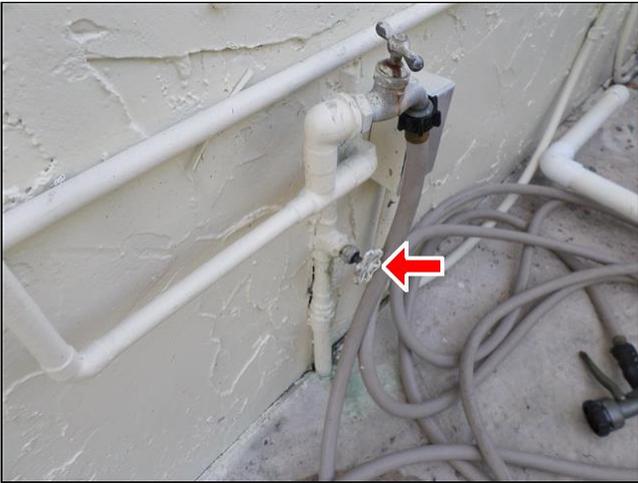
6.3 Item 1(Picture)

**6.3** The main shut off is the knob located outside on the left side of the home. This is for your information.

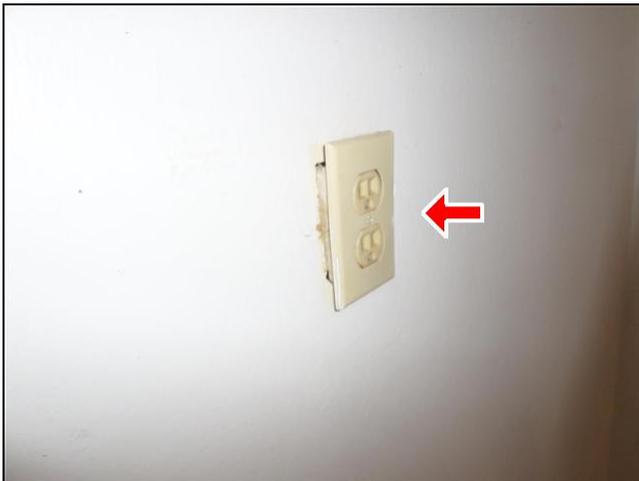
7.3 Item 1(Picture)

**7.3** One "three-prong" outlet is loose in wall in the utility room. Electrical issues should be repaired. I recommend repair as needed.

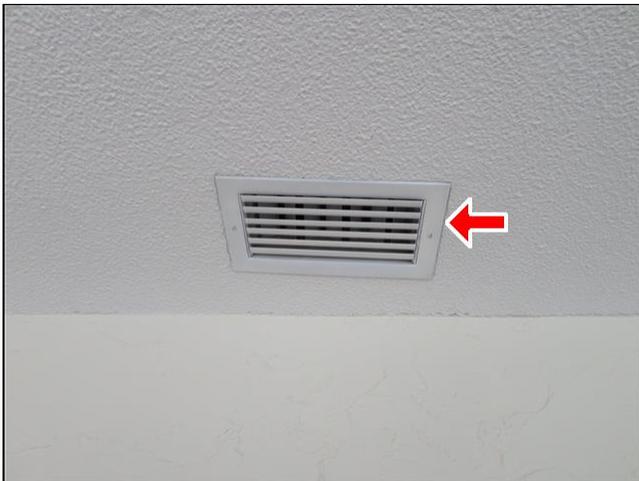
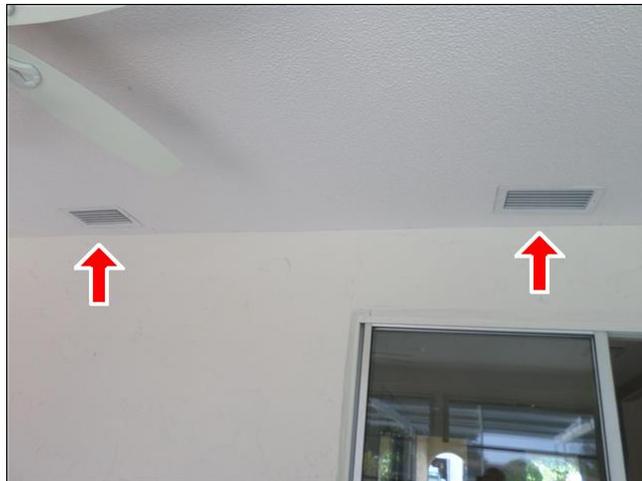
8.3 Item 1(Picture)

**8.3** The duct work for the air conditioning and heat is in place but is currently not hooked up in the lanai. This is for your information.

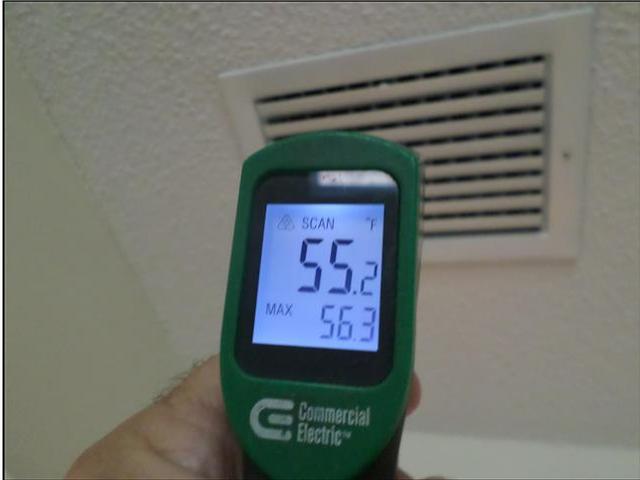
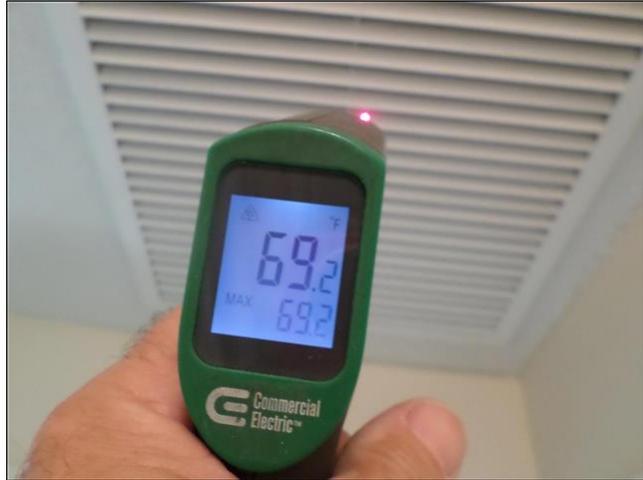
8.5 Item 1(Picture)

**8.5** The ambient air test was performed by using thermometers on the air handler of Air conditioner to determine if the difference in temperatures of the supply and return air are between 14 degrees and 22 degrees which indicates that the unit is cooling as intended. The supply air temperature on your system read 55 degrees, and the return air temperature was 69 degrees. This indicates the range in temperature drop is normal.

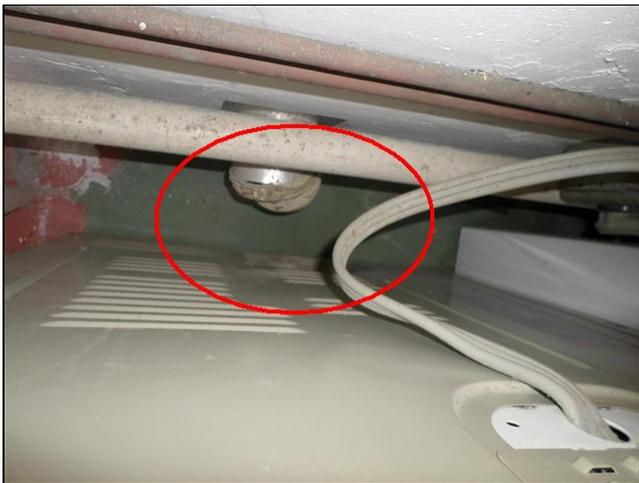
9.2 Item 1(Picture)

9.2 The dryer vent piping is disconnected behind the dryer. This is for your information.

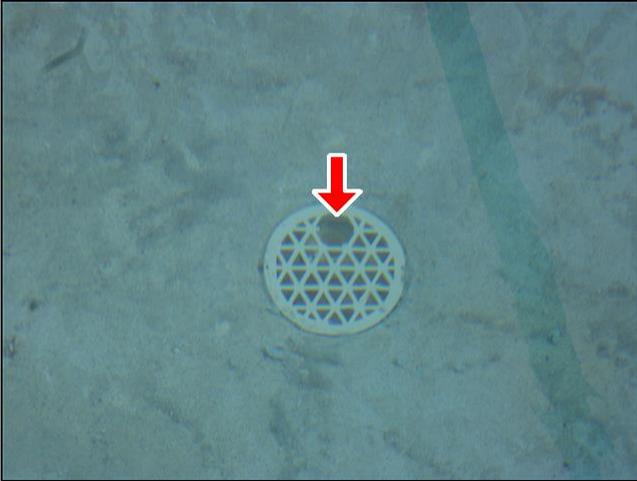
12.7 Item 1(Picture)

**12.7 (1)** The pool drain cover is damaged. A repair or replacement is needed. A qualified person should repair or replace as needed.

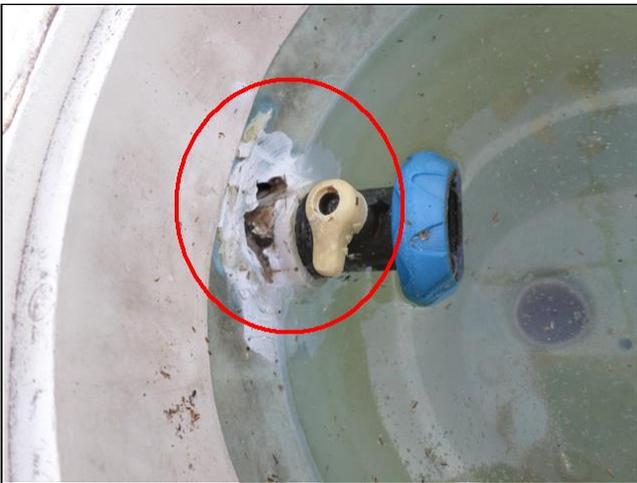
12.7 Item 2(Picture)

**(2)** The plastic piping needs caulking inside the skimmer. This is a small repair. I recommend repair as needed.
